LIGHTHOUSE ENGINEERING, L.L.C.

RE: Engineering Evaluation – Foundation Performance
Home Owner Name, 6789 ANYSTREET LANE., IRVING, TEXAS 75063
Job No. 4229511A38; Original Closing Date: 12-16-2005

The following report constitutes the engineering opinion requested on the foundation of the subject residence. This report has been prepared in general accordance with the requirements of a “Level B” survey as defined by the Texas Chapter of the American Society of Civil Engineers (ASCE) and the Texas Board of Professional Engineers (<http://texasce.org/associations/10803/files/RepairGuidelines.pdf>). This report is provided for the exclusive use of the person or persons this report was prepared for as shown above. We have no contractual relationship with, or obligation to, any party other than the party for whom this report was prepared. The purpose of this inspection was to evaluate the foundation and determine what, if any, foundation repairs are necessary. The foundation was visually inspected and a floor elevation survey was performed. The opinions contained herein are based on the experience and judgment of the writer, as well as conditions observed without taking soil samples, per

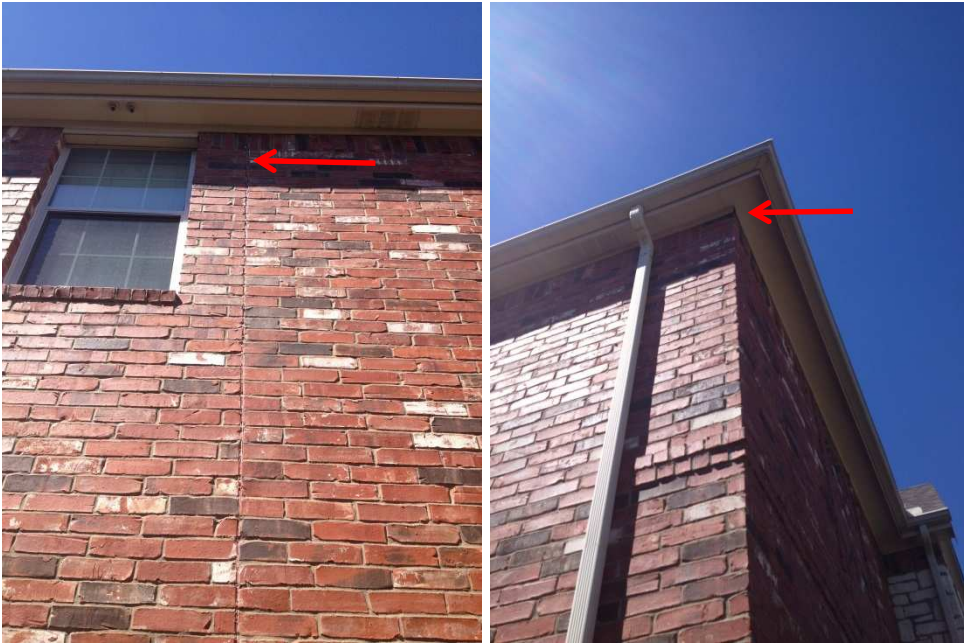
2. **Exterior Observations:** Indications of minor settlement at the front left corner.
 - a. Left rear brick expansion joint separation (0.0"@0' to 1.0"@20').

- b. Left front brick expansion joint separation (0.0"@0' to ¼"@20').
 - c. Left front frieze board separation (separation ¾").
 - d. Sightdown the brickline along the left side shows minor brickline deflection.

Picture 1 and 2: Indications of minor settlement at the front left corner. Minor expansion joint separation at top and frieze board separation at front left corner.

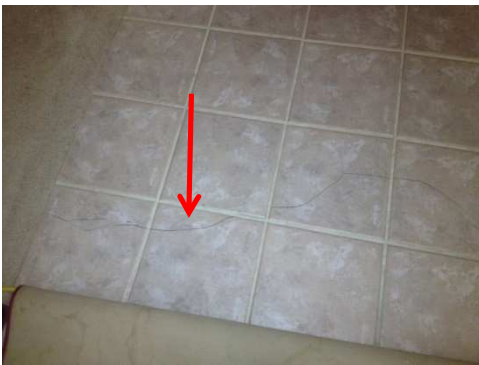
3. **Interior Observations:** Indications of minor settlement at the front left corner.
 - a. There are hairline tile crackings in the front entry, kitchen and master bathroom. These types of crackings are caused from the normal drying process of the concrete foundation. As the concrete dries, it develops hairline "resistance to shrinkage" (RTS) crackings on the surface. When brittle tiles are laid over these RTS crackings, the normal structural vibrations and seasonal movements of the foundation translate into the tile causing the tiles to crack. These types of hairline tile crackings are not indicative of a structural deficiency.

Picture 3: Hairline tile cracking in the front entry, kitchen and master bathroom. These are not indicative of a structural deficiency.

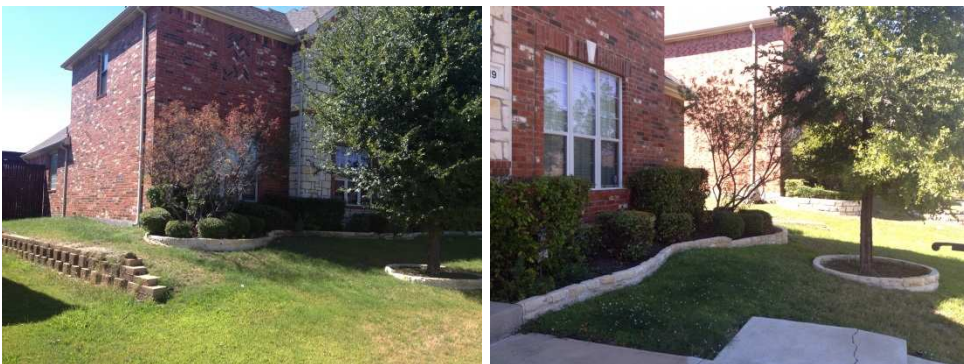
- h. Right rear brick expansion joint no separation (separation 0.0").
 - i. Two (2) large trees in the front yard (see pictures 4 and 5 below).
 - j. The topography of the lot is gently sloping downward from right to left. There appears to be some amount of fill dirt along the left side that was used to level the lot during construction. The exact preparation of this (apparent) fill dirt is not known.

Picture 4 and 5: View of the left and right front of the home. It is hypothesized that there may be fill dirt compaction at the front left corner. This fill dirt compaction, and the large trees, may be contributing to the minor settlement at this corner.

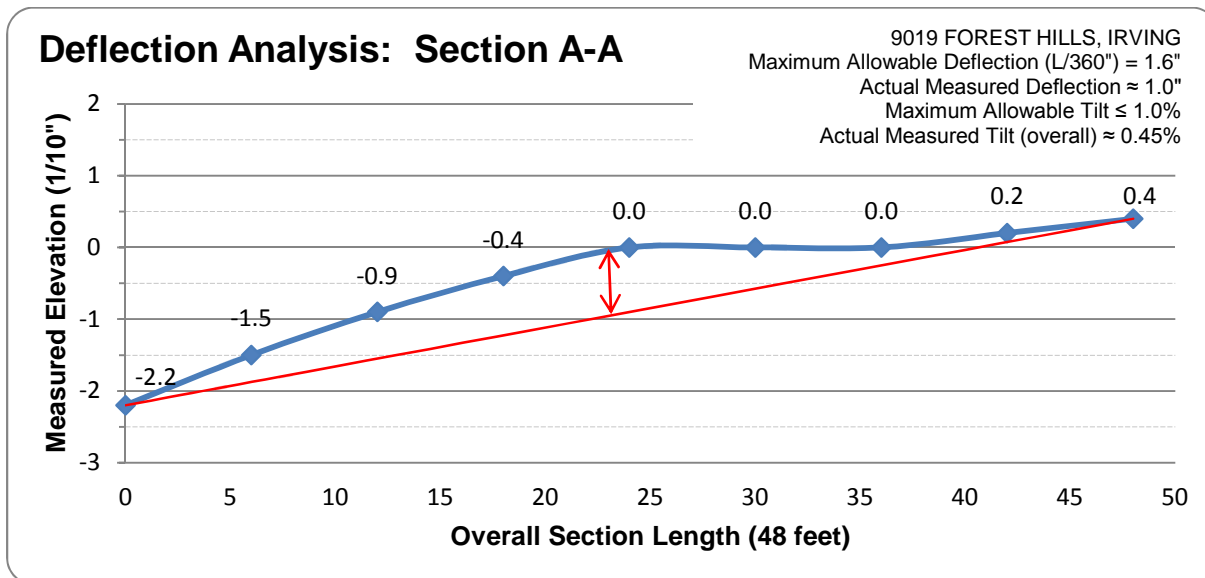
Figure 1: Deflection Analysis Cross Section A-A

6. **Elevation Analysis:** Industry standard tolerance for foundation performance (as defined by the Texas Chapter of the ASCE) is less than L/360 overall or local deflection and 1.0% tilt. This criteria, and my experience and judgment, was used to evaluate the performance of the foundation. Figure 1 below shows a graphical depiction of the actual deflection and tilt across the profile section A-A as shown on Drawing 1001.

- a. The maximum allowable deflection is $L/360'' = 576''/360'' = 1.6''$ and the actual deflection was measured to be $\approx 1.0''$. This is less than the maximum allowable tolerance for deflection.

- b. The actual (overall) tilt was measured to be $\approx 0.45\%$. This is less than the maximum allowable tolerance for tilt.

7. **Conclusion:** The actual deflection and tilt of the foundation is **LESS THAN the maximum allowable limits**. Based on this analysis, the magnitude and severity of the deflection, tilt and cosmetic indicators of movement do not warrant the need for structural foundation repairs at this time. Some minor movement of

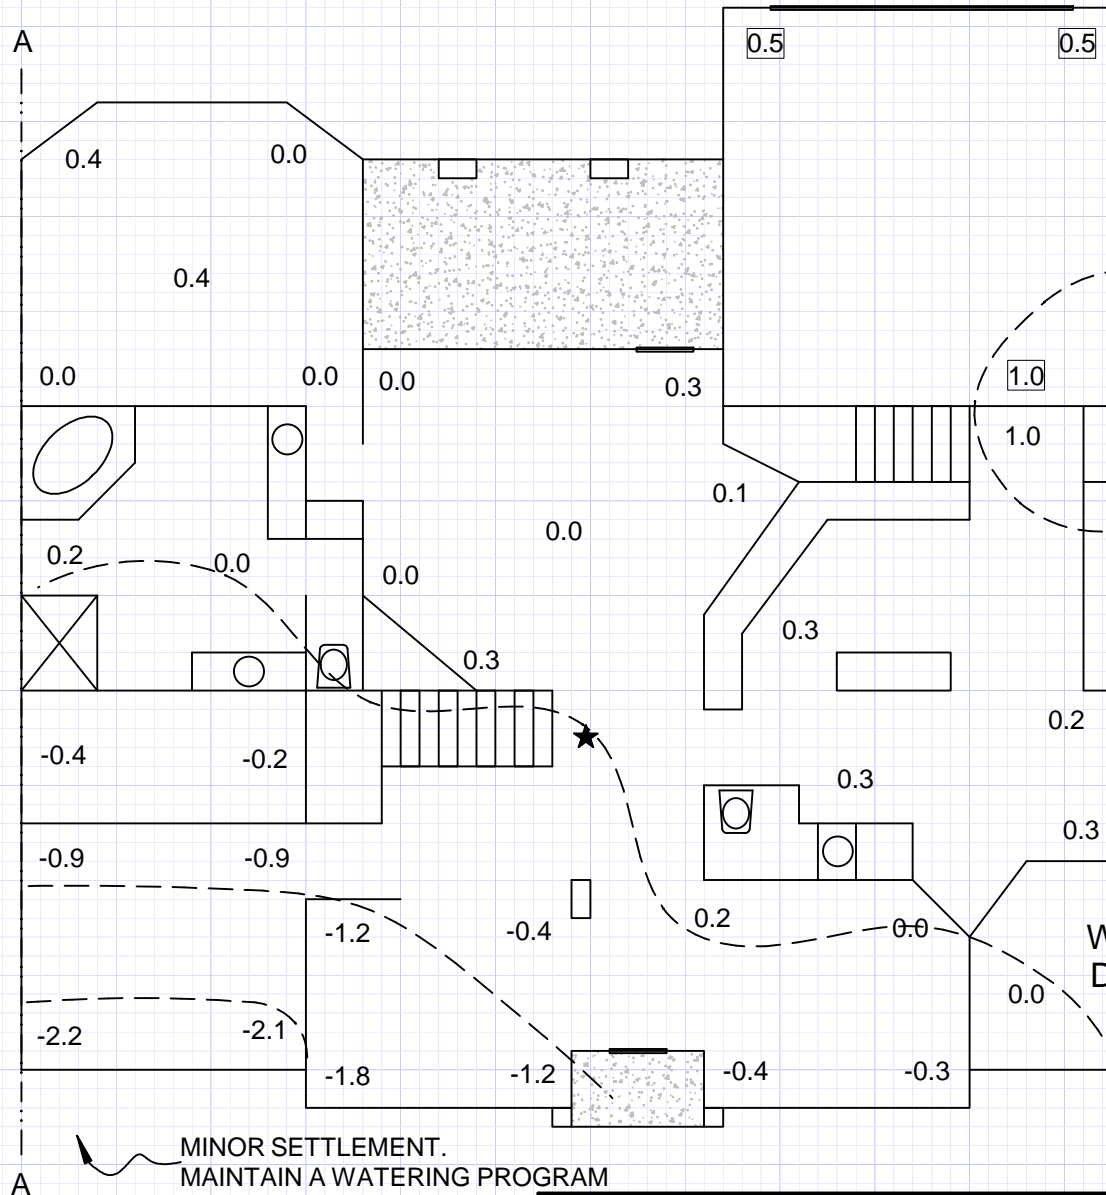
Interior floor elevations were taken with a Technidea Pro-2000 Zipllevel. Elevations were recorded to the nearest .1-inch throughout the home. A benchmark of 0.0 was established in the middle floor plan and is shown on drawing no. 1001 with a star. An adjustment was made for floor coverings if they were a different elevation than the floor covering at the benchmark location. Elevation differentials varied by a maximum of -3.2 vertical inches in 67 horizontal feet. It should be noted that the elevation measurements include effects of elevation variation in the original construction which normally are 0.6 inches to 1.0 inches. A sketch of the house with the elevations is attached as Drawing 1001.

- a. It is recommended to check ALL sprinkler heads for leaks. There may be a sprinkler leak located along the right side (see Drawing 1001). Repair ALL sprinkler head leaks if they are discovered.
- b. Maintain a watering program in the dry months of the year to prevent the soil around the home from drying and cracking. If soaker hoses are used, place the soaker hoses 1' – 2' away from the foundation and run for 30 – 60 minutes every other day as needed.
- c. It is recommended to make cosmetic adjustments to all interior doors to allow for proper door operation. Make cosmetic repairs to sheetrock, as desired.
- d. If the homeowner desires to reduce these minor slopes, foundation lifting piers could be installed as recommended by Mr. Osborne, PE. However, these would be considered a cosmetic adjustment, not a structural necessity.
